# City of Longview

### Historic Preservation Commission

**19-000191 Columbia Theatre Door replacement project**

## STANDARDS FOR REHABILITATION & GUIDELINES FOR REHABILITATING HISTORIC BUILDINGS

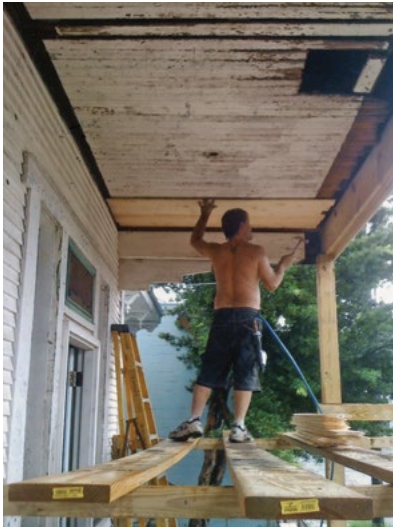
[24] Rotted boards in the beaded-board porch ceiling are being replaced with new matching beaded board.

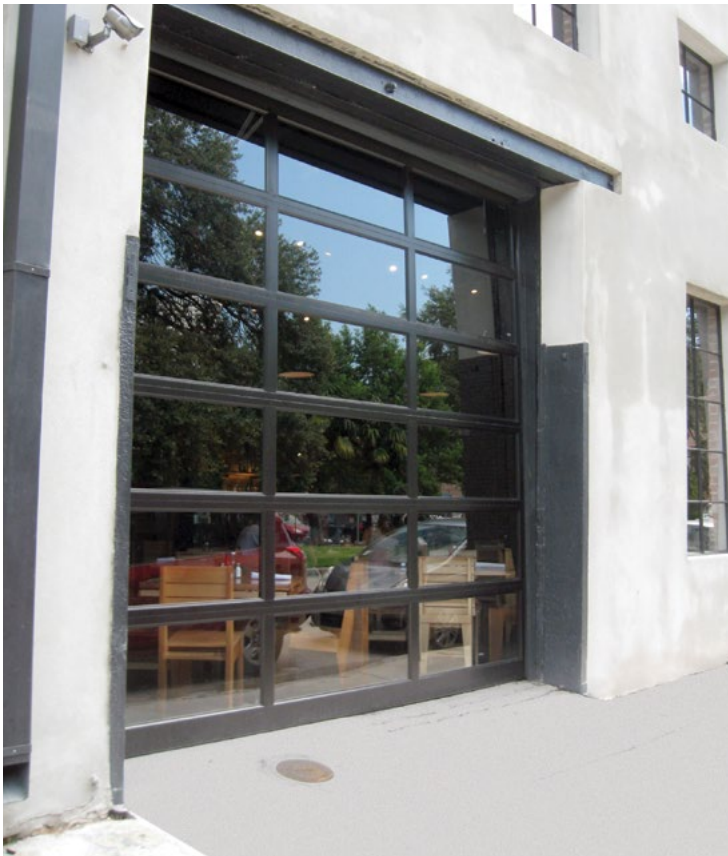
[25] The new infill designs for the garage door openings in this commercial building (a) converted for restaurant use and in this mill building (b) rehabilitated for residential use are compatible with the historic character of the buildings.

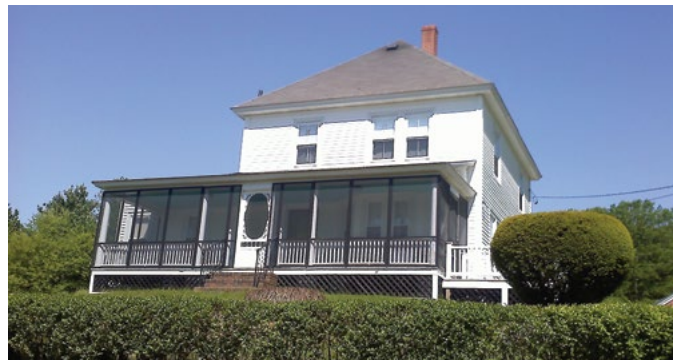
[26] **Not Recommended:** Installing a screened enclosure is never recommended on a front or otherwise prominent historic porch. In limited instances, it may be possible to add screening on a porch at the rear or on a secondary façade; however, the enclosure should match the color of the porch and be placed behind columns and railings so that it does not obscure these features.

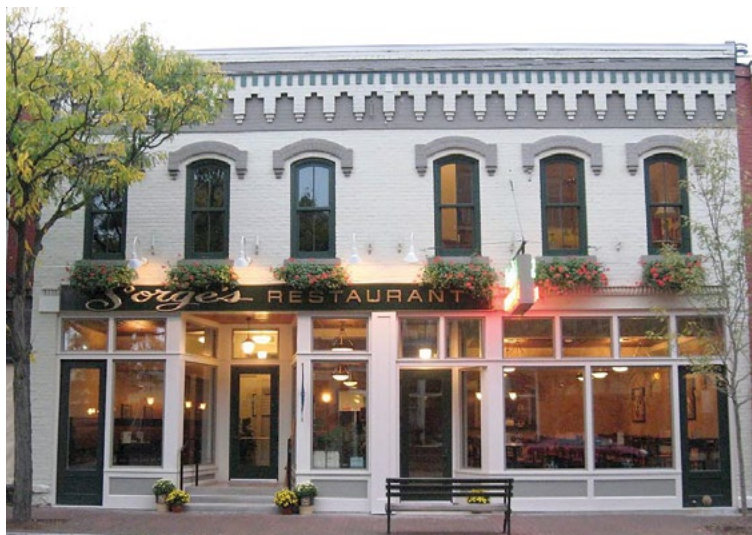
[28] This new storefront, which replaced one that was missing, is compatible with the historic character of the building.

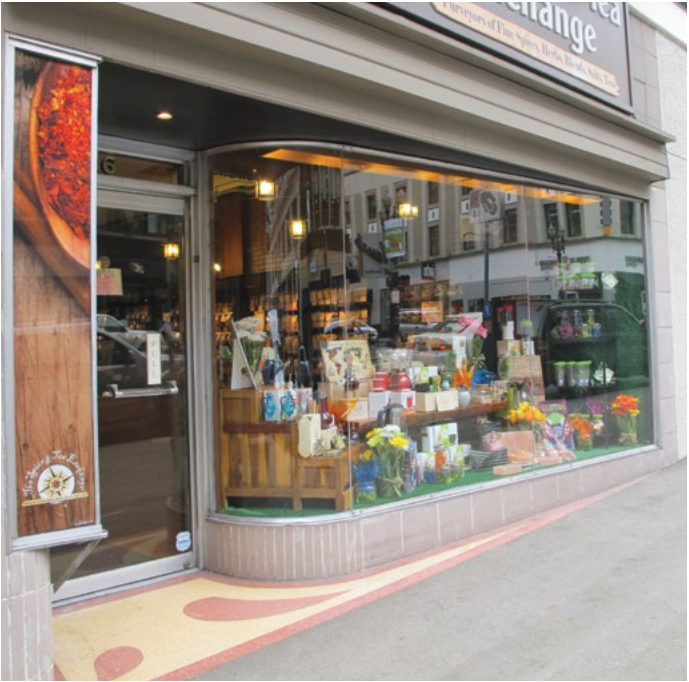
[27] This original c. 1940s storefront, with its character-defining angled and curved glass display window and recessed entrance with a decorative terrazzo paving, is in good condition and should be retained in a rehabilitation project.

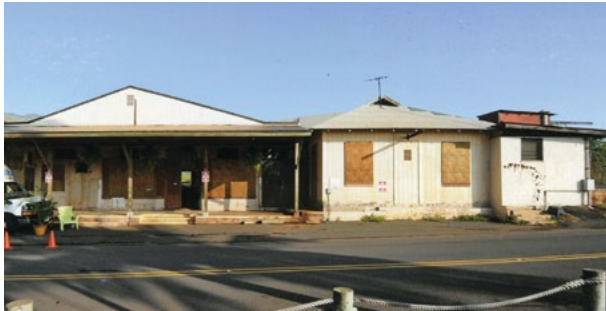
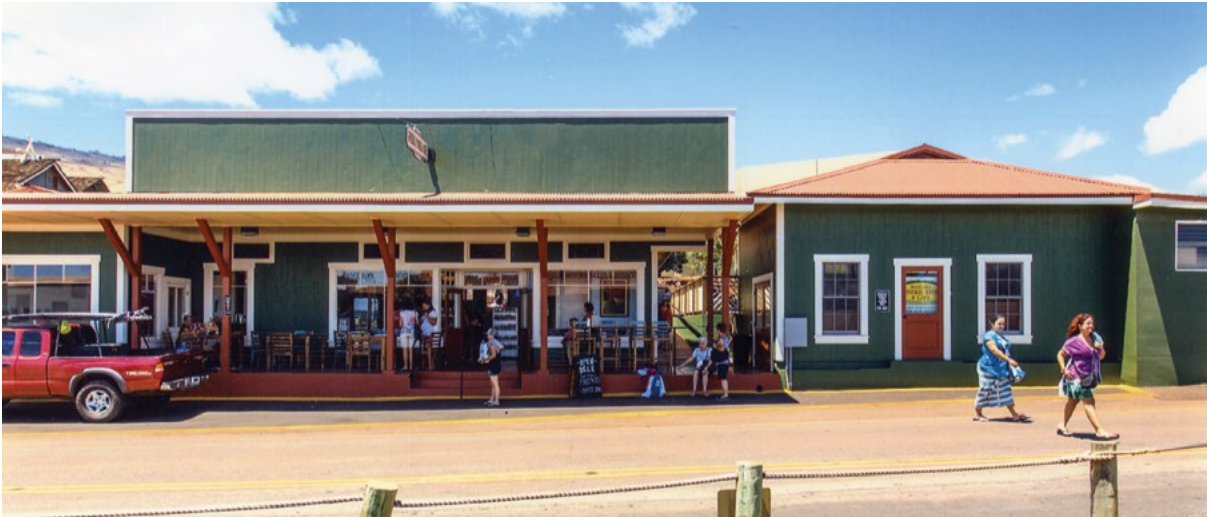
[29] The rehabilitation of the 1910 Māālaea General Store (a), which served the workers' camp at the Wailuku Sugar Company on the Hawaiian island of Maui, included the reconstruction of the original parapet (b).

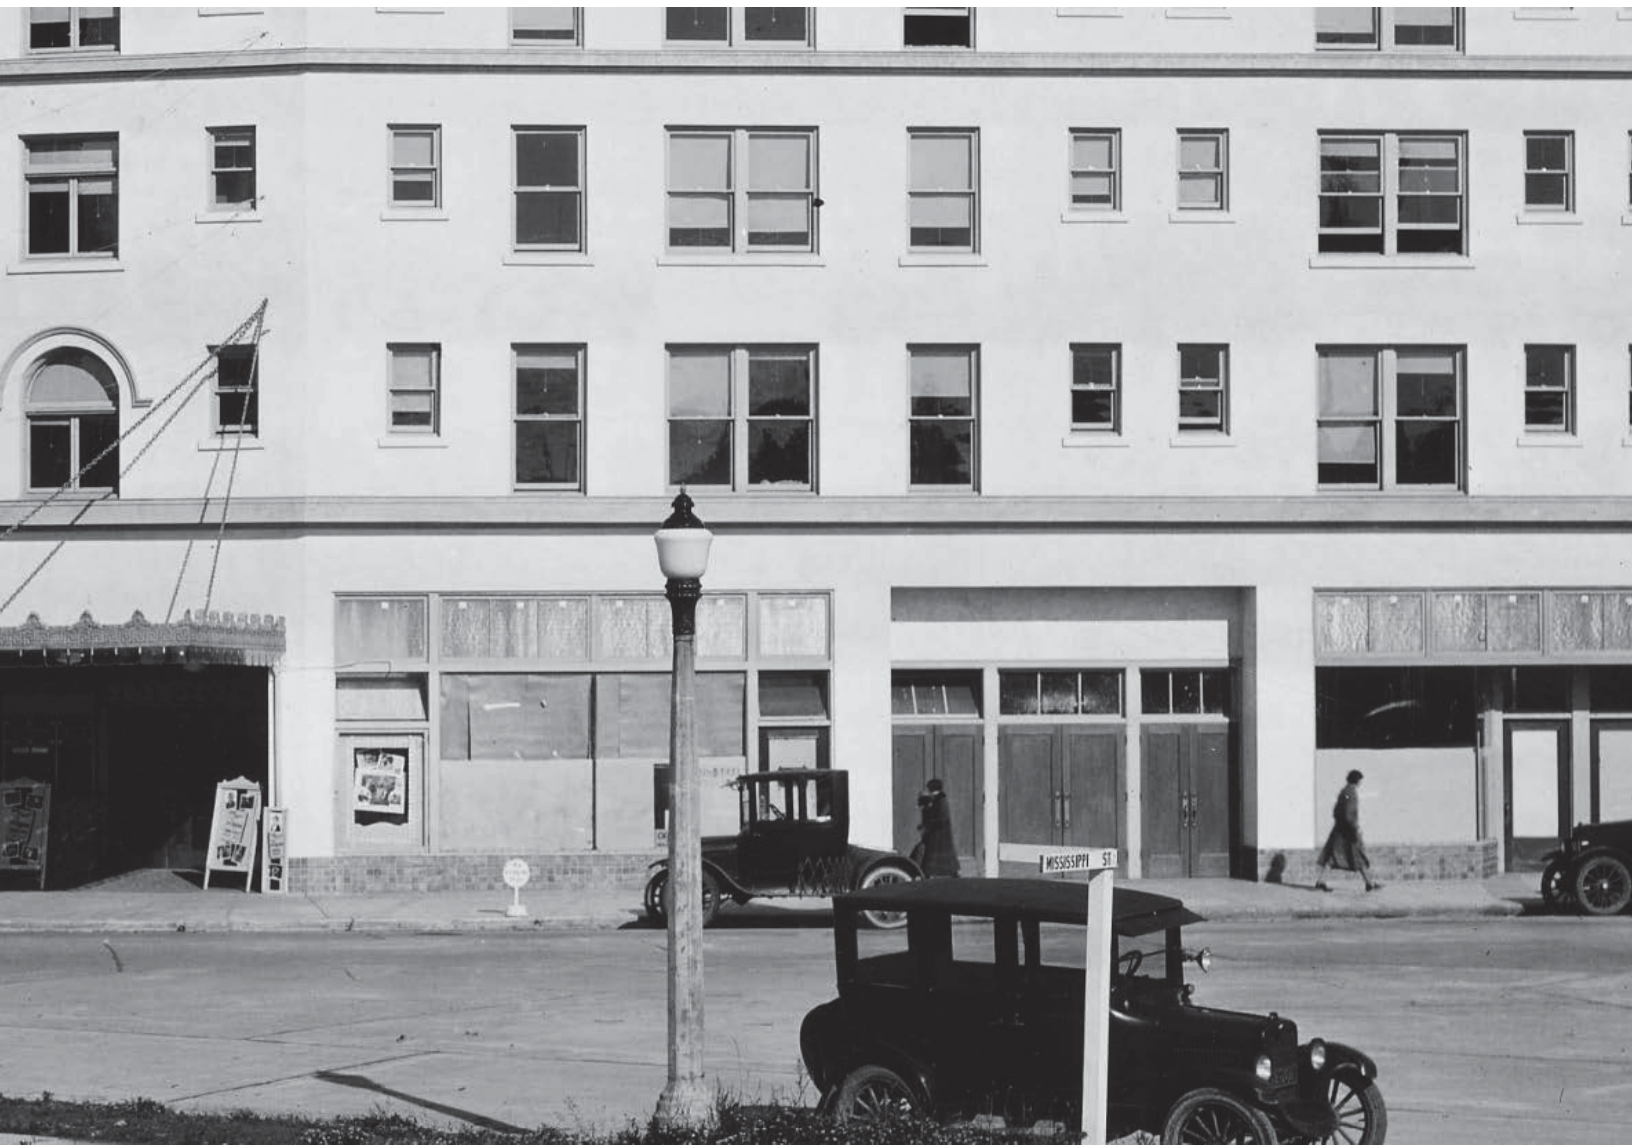
Attached: Photos of the Columbia Theatre doors
